# Special Protection Area Program Annual Report 2007

Prepared by the Montgomery County Department of Environmental Protection in Cooperation With the Department of Permitting Services and the Maryland-National Capital Park and Planning Commission

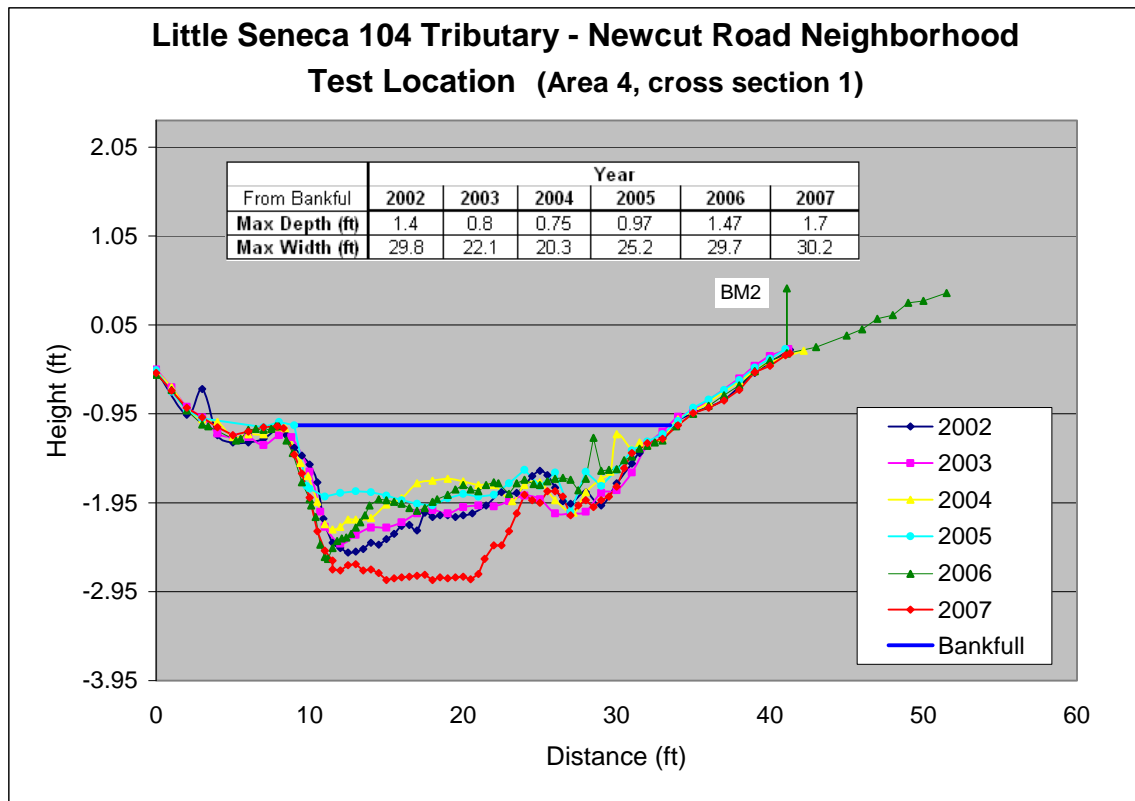
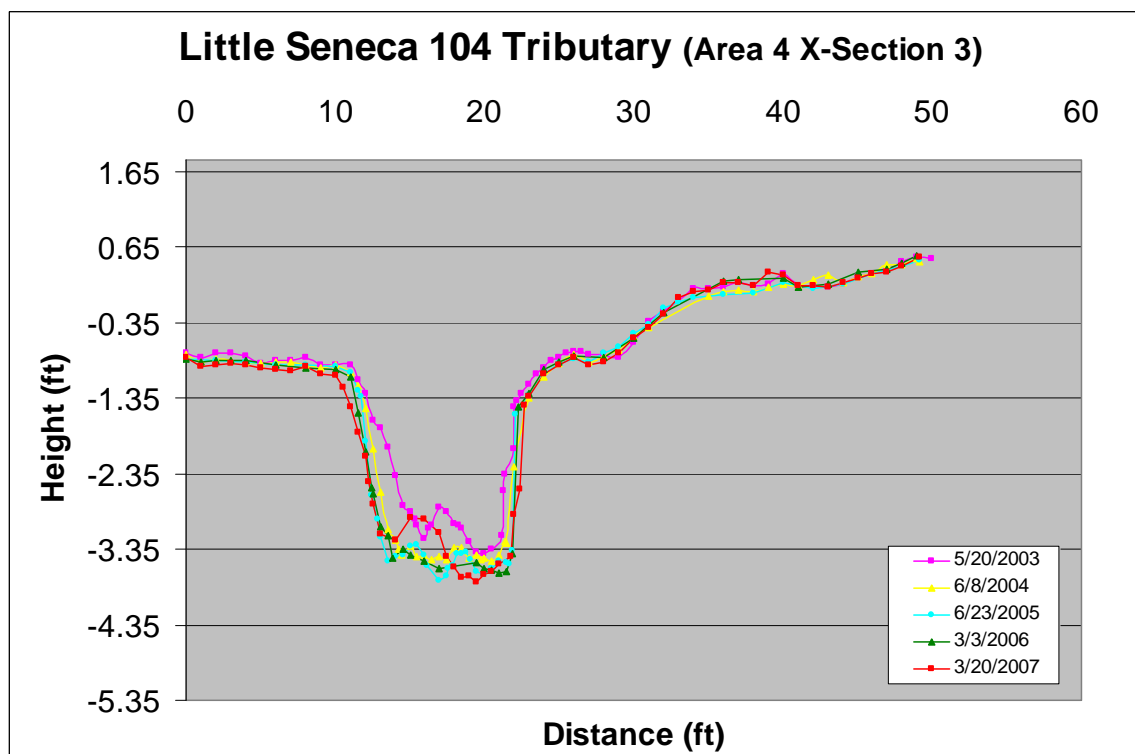
**Figure 4.10. Representative cross sections from Newcut Road Neighborhood, Little Seneca 104 Tributary test location, Area 4. Cross sections are both measured in Riffle/run features.**

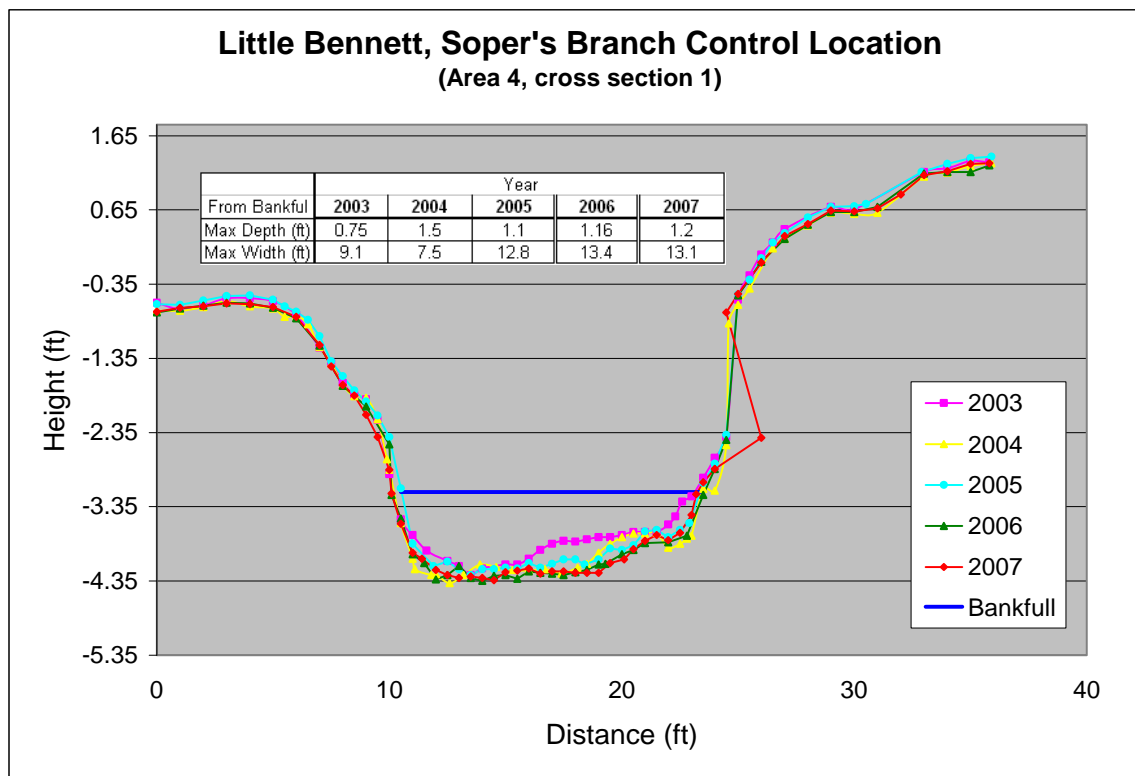
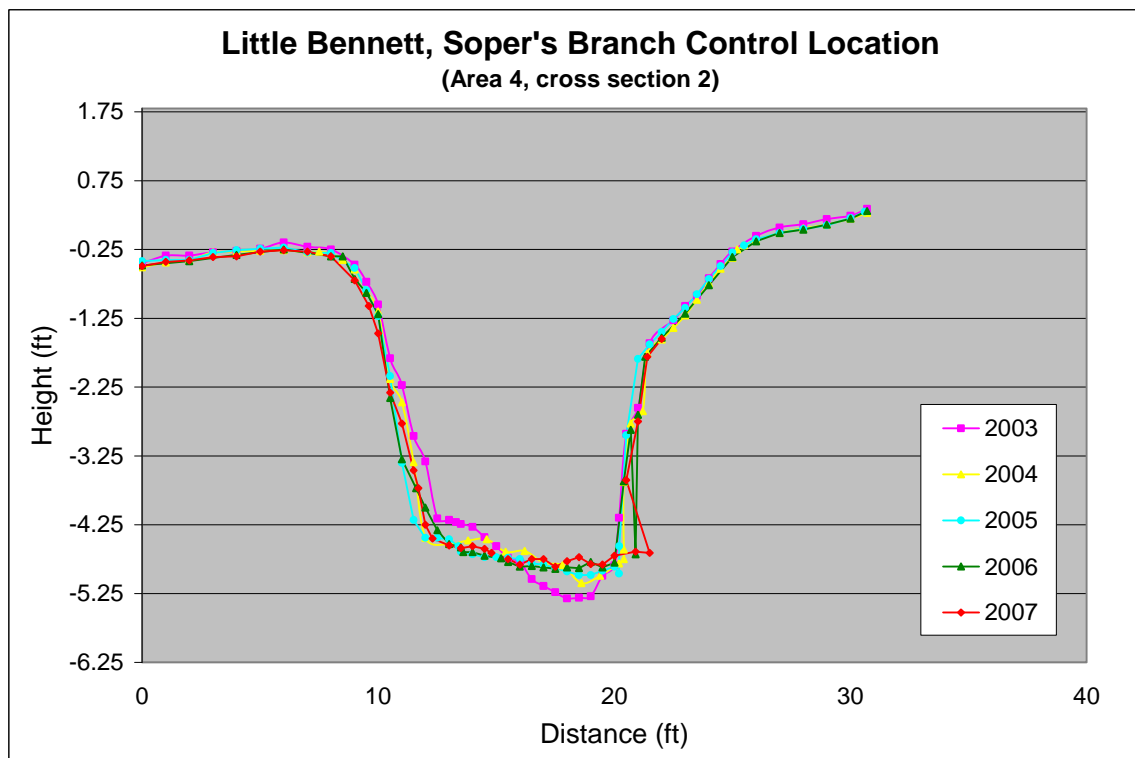
**Figure 4.11. Representative cross sections from Little Bennett Creek, Sopers Branch control location, Area 4. Cross sections both measured in Riffle/run features.**

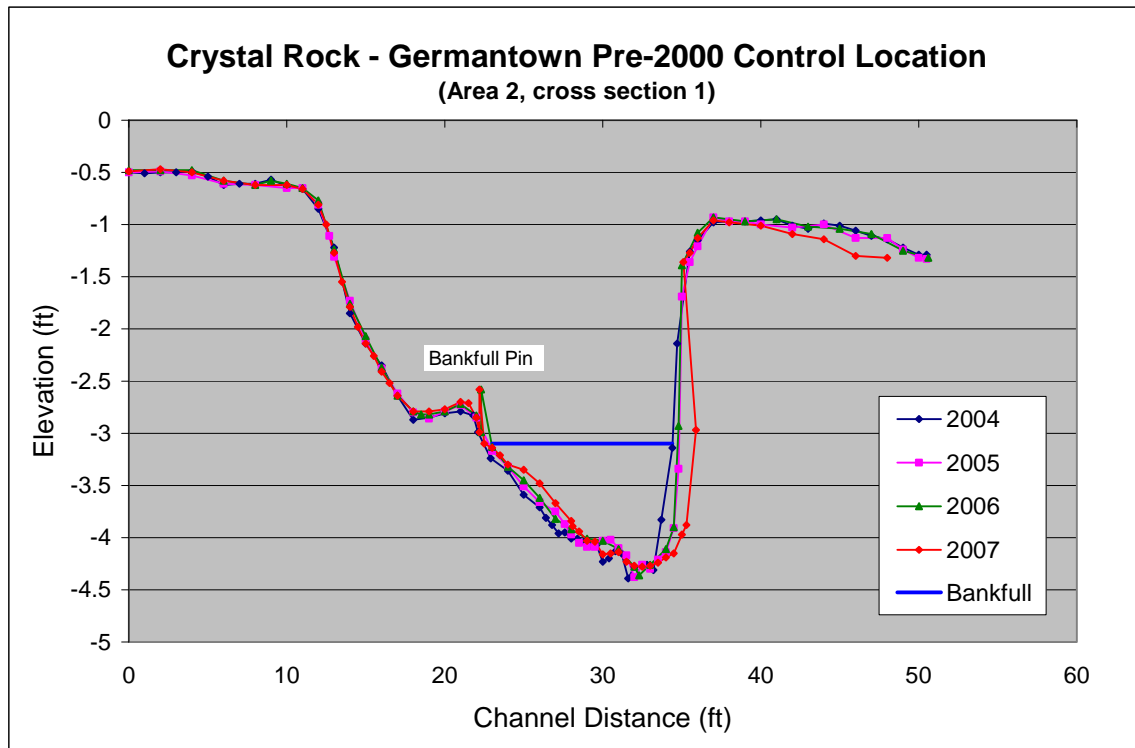
**Figure 4.12. Representative cross sections from Germantown (Crystal Rock) pre-2000 control location, Area 2. Cross section 1 measured in a Riffle/run feature.**

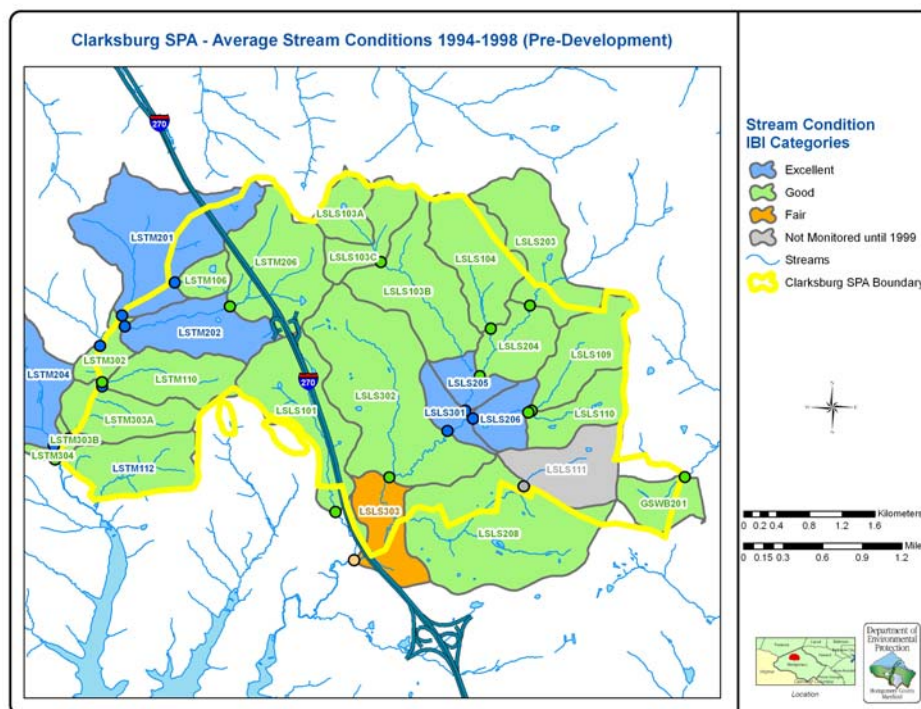
**Figure 5.1. Pre-development (1994-1998)) stream conditions (average of fish and benthic % IBI scores) in the Clarksburg SPA.**

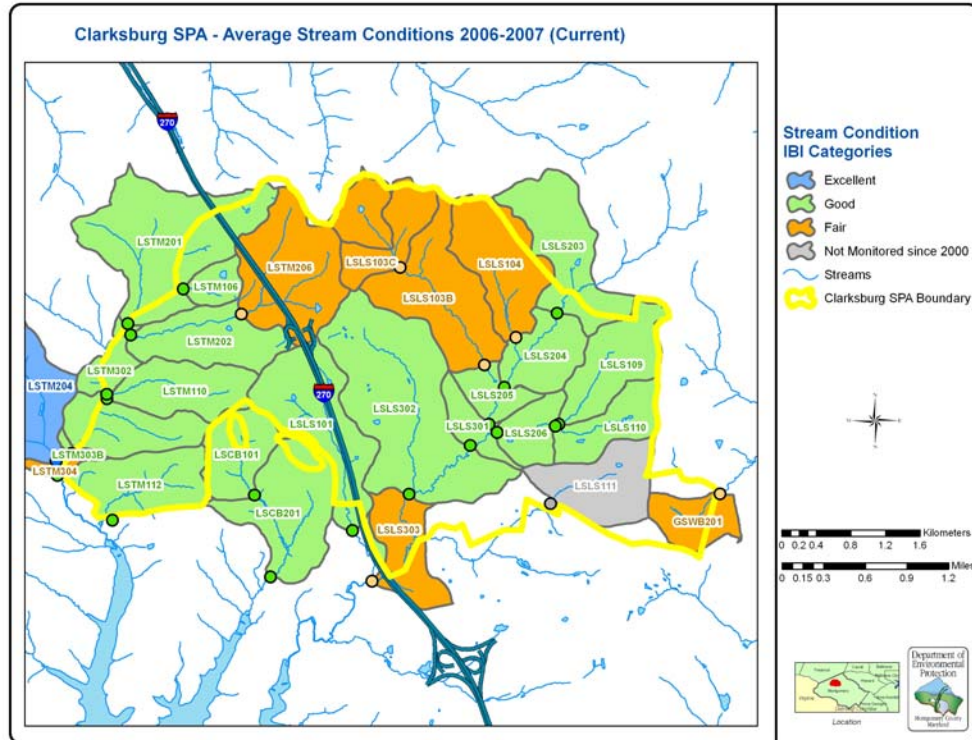
**Figure 5.2. Current (2006 & 2007) stream conditions (average of fish and benthic % IBI scores) in the Clarksburg SPA.**

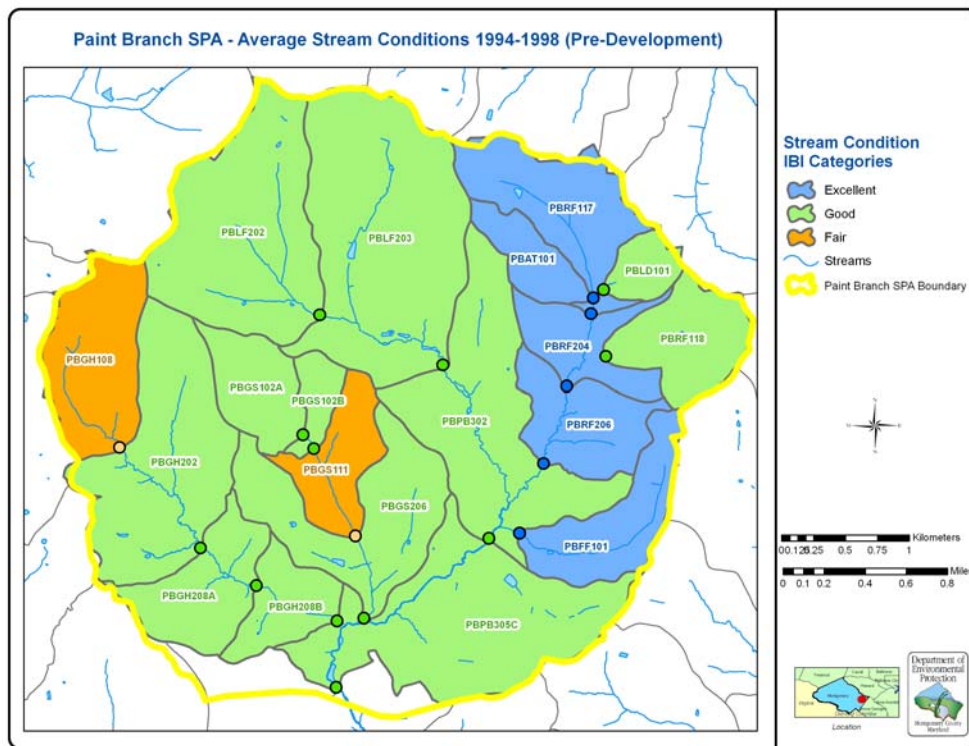
**Figure 5.3. Pre-development (1994-1998) stream conditions (average of fish and benthic % IBI scores) in the Paint Branch SPA.**

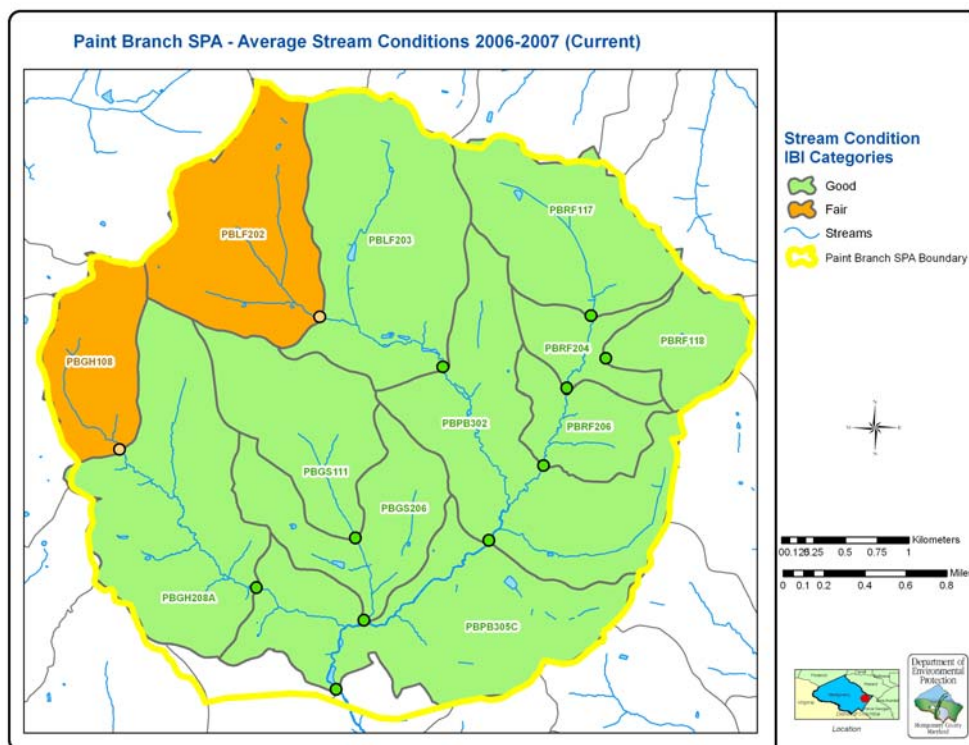
**Figure 5.4. Current (2006 & 2007) stream conditions (average of fish and benthic % IBI scores) in the Paint Branch SPA. Stations PBGS102A, PBGS102B, PBGH202, PBAT101, and PBRF101 were not monitored in recent years due to monitoring priorities in other SPAs, so their drainage areas were absorbed by downstream active stations.**

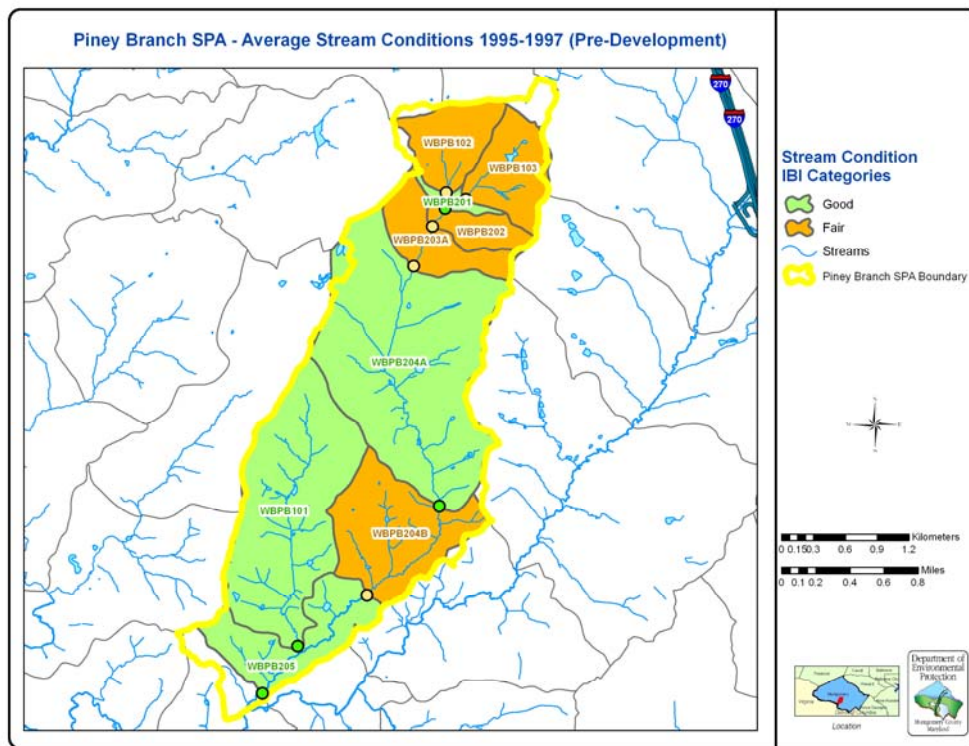
**Figure 5.5. Pre-development (1995-1997) stream conditions (average of fish and benthic % IBI scores) in the Piney Branch SPA.**

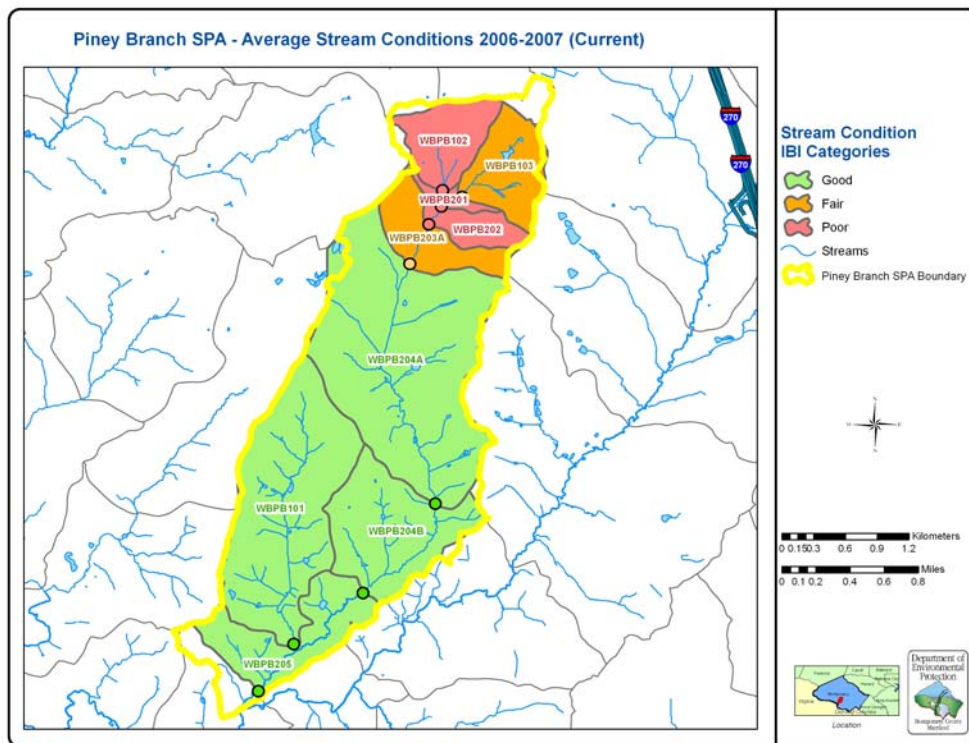
**Figure 5.6. Current (2006 & 2007) stream conditions (average of fish and benthic % IBI scores) in the Piney Branch SPA.**

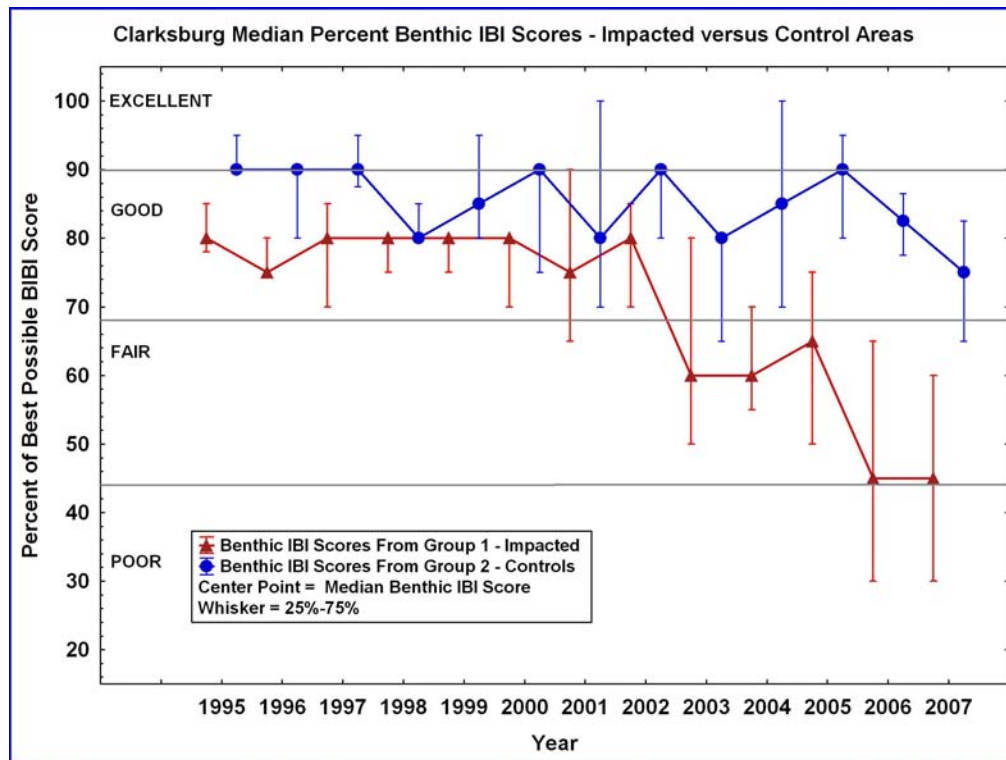
**Figure 5.3. Median Benthic IBI Scores for Clarksburg Control and Test Areas.**

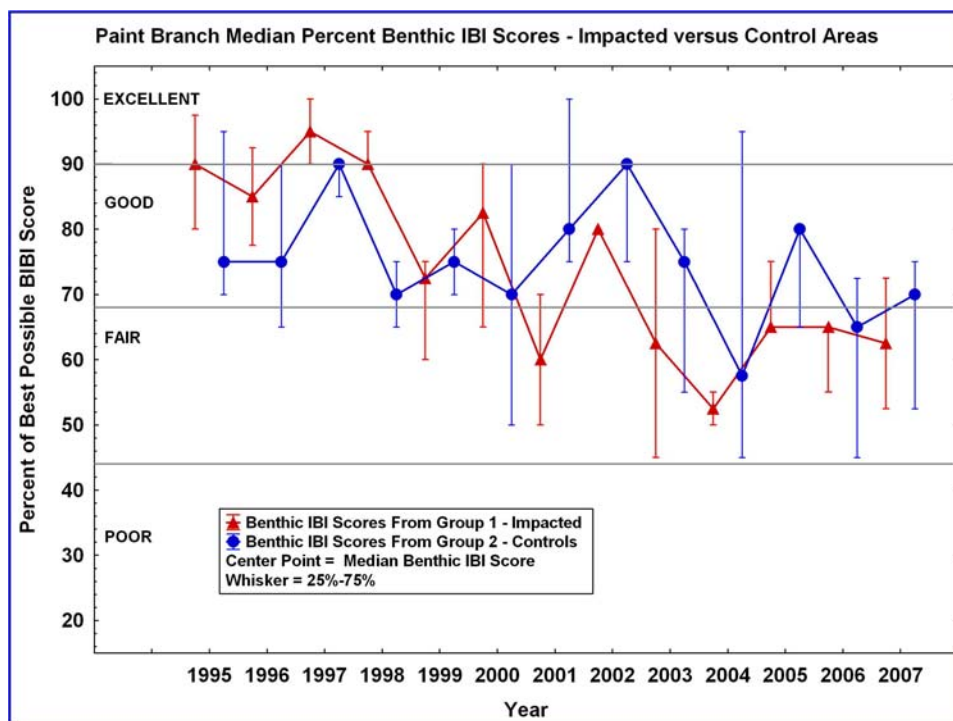
Figure 5.5. Median benthic IBI scores for Upper Paint Branch control and test areas.

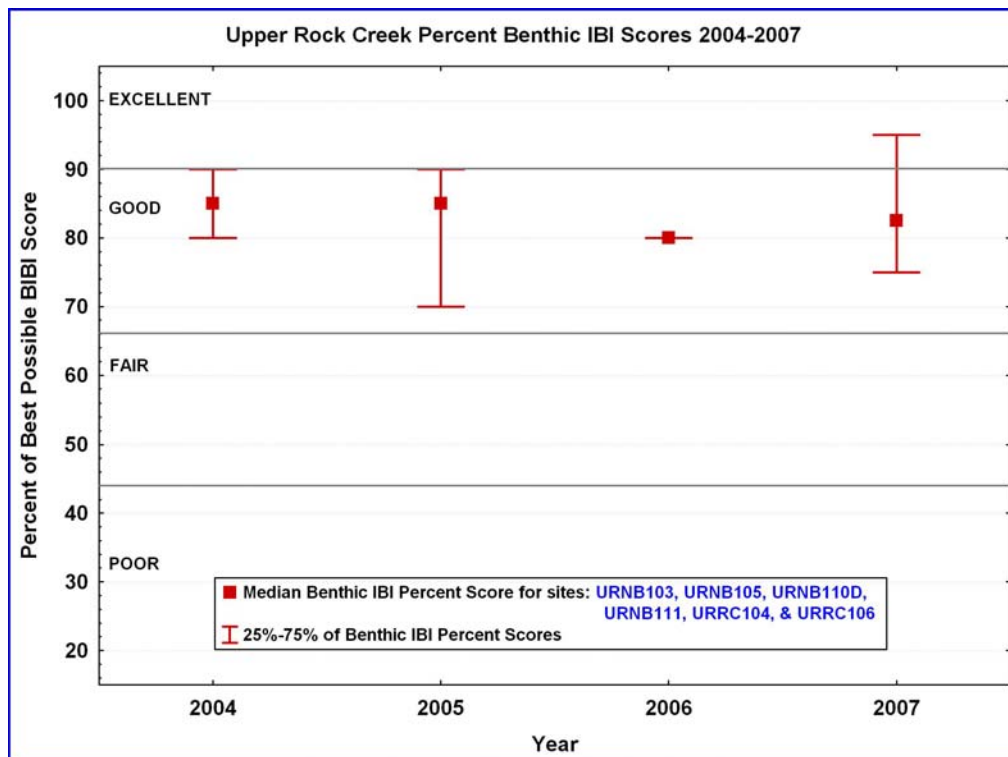
**Figure 5.6. Median benthic IBI scores for Upper Rock Creek control and test areas.**

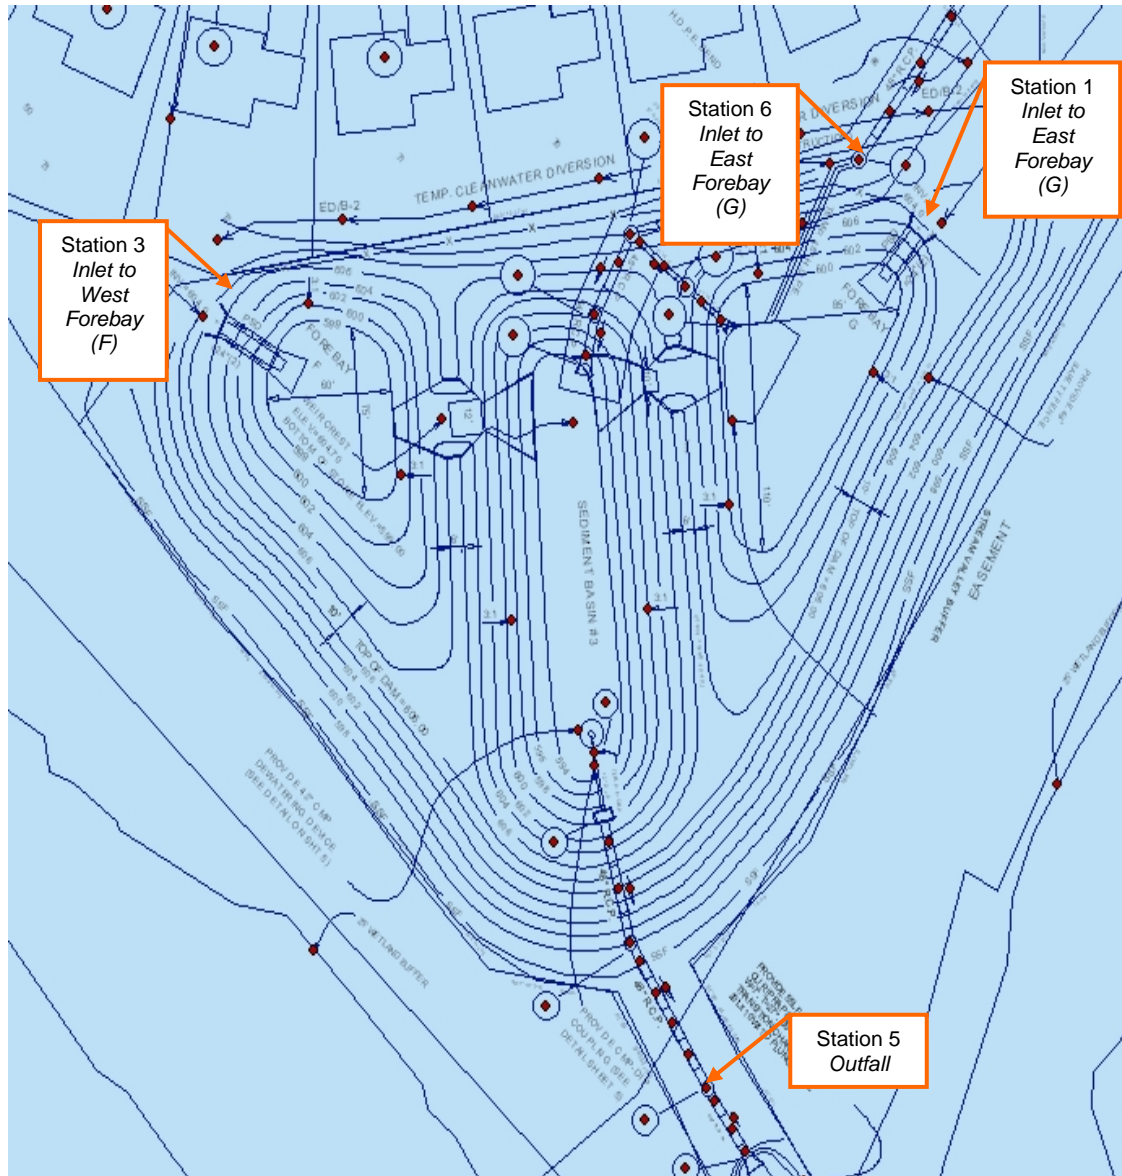
**Figure TA-3.6. Plan view of Clarksburg Town Center Sediment Basin #3.** Final monitoring stations (4) are indicated.

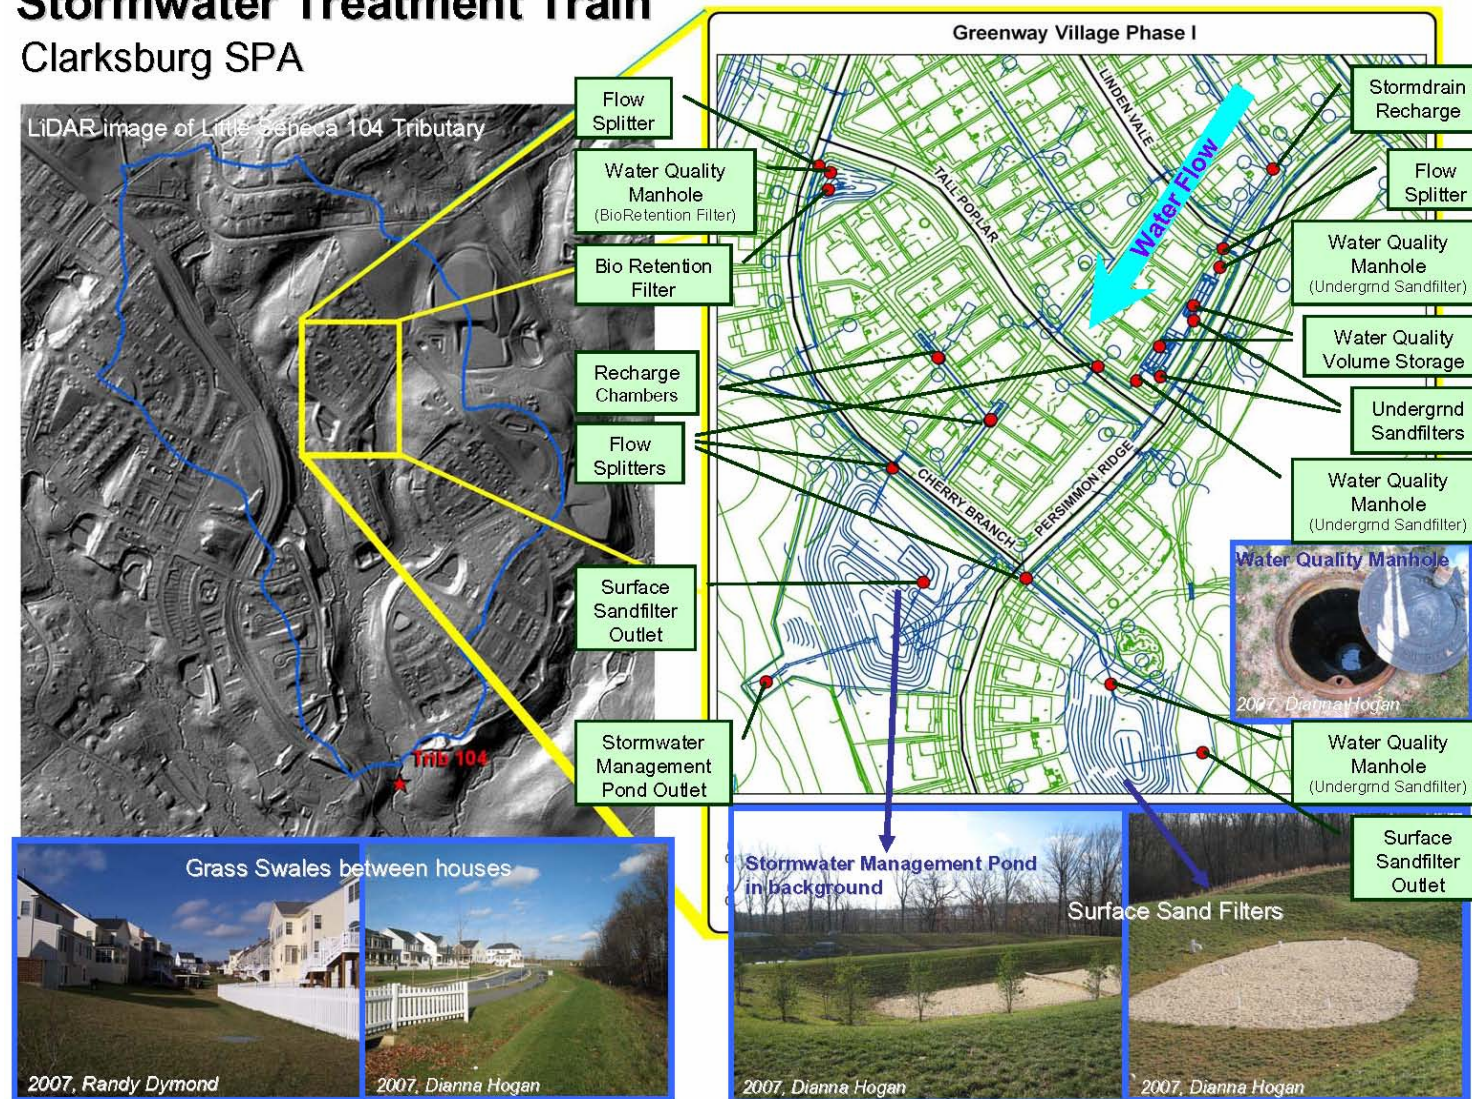
**Figure TA-3.9. Enlargement of a section of the 2007 LiDAR image of Greenway Village Development (Newcut Road Neighborhood) showing the redundant water quality and quantity SWM BMPs designed to mitigate imperviousness impacts.**

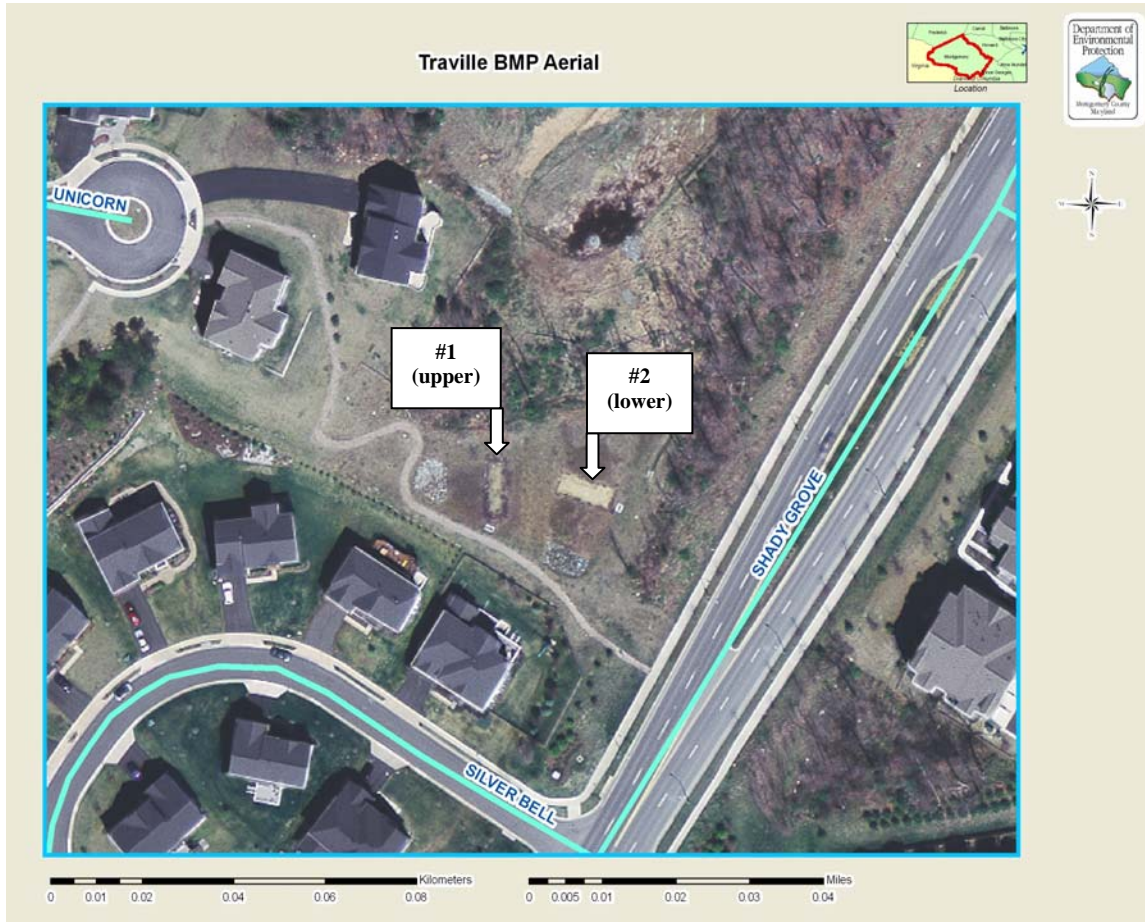
**Figure TA-3.10. Willow Oaks Sand Filters.**

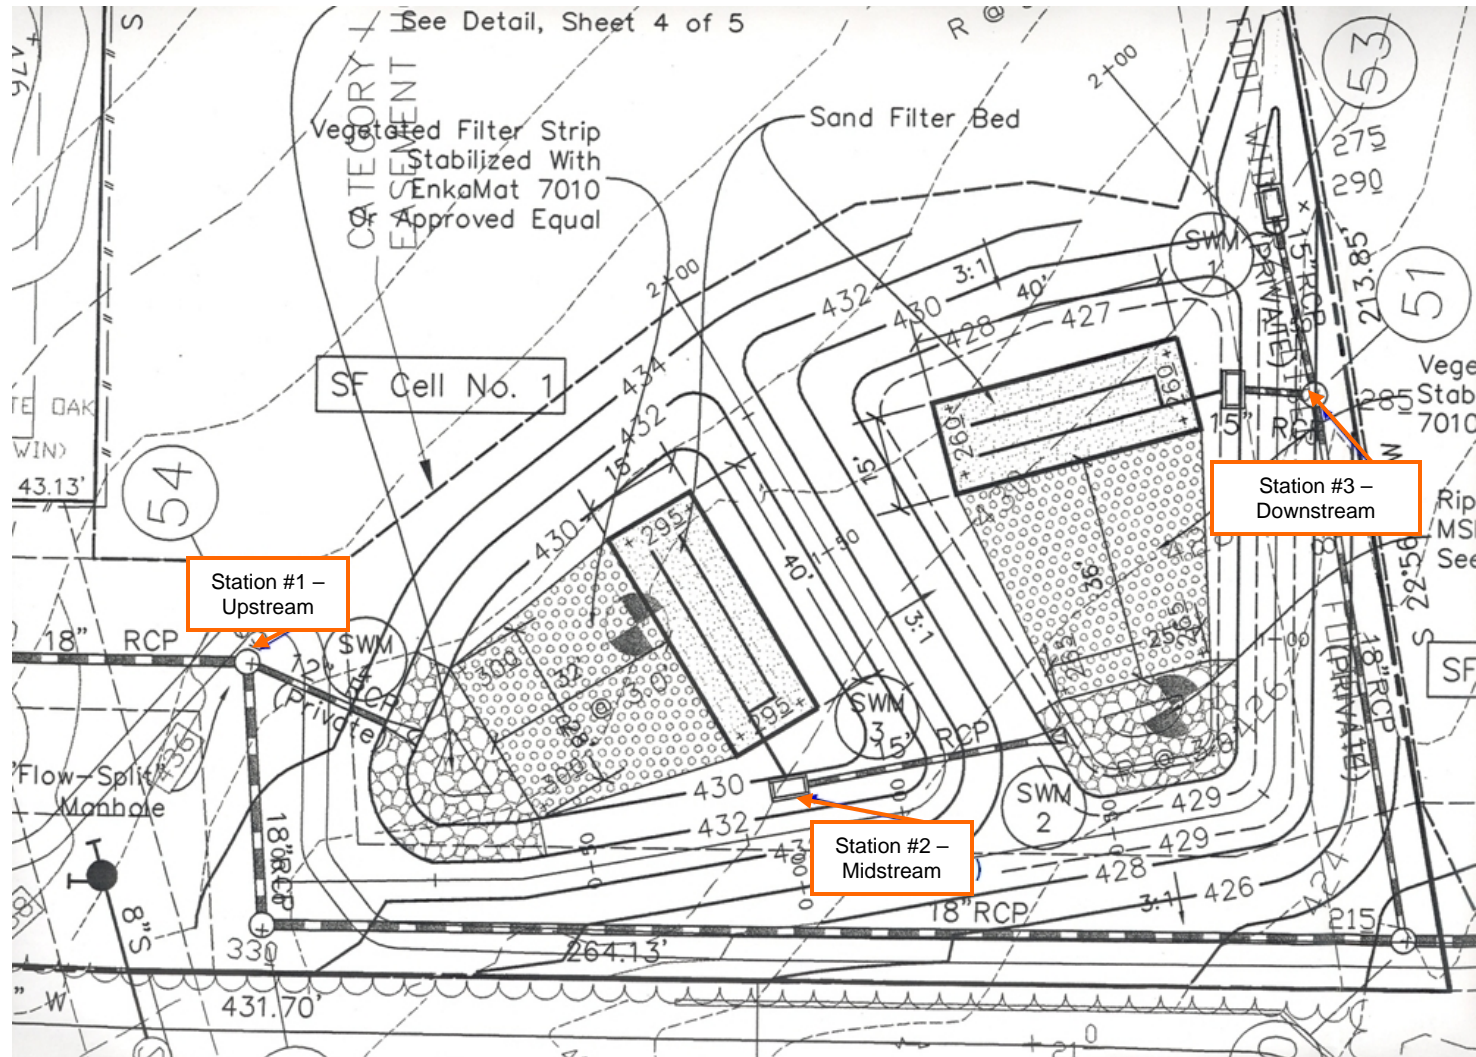
Figure TA-3.11. Plan view of Willow Oaks BMP with monitoring locations (3) denoted.

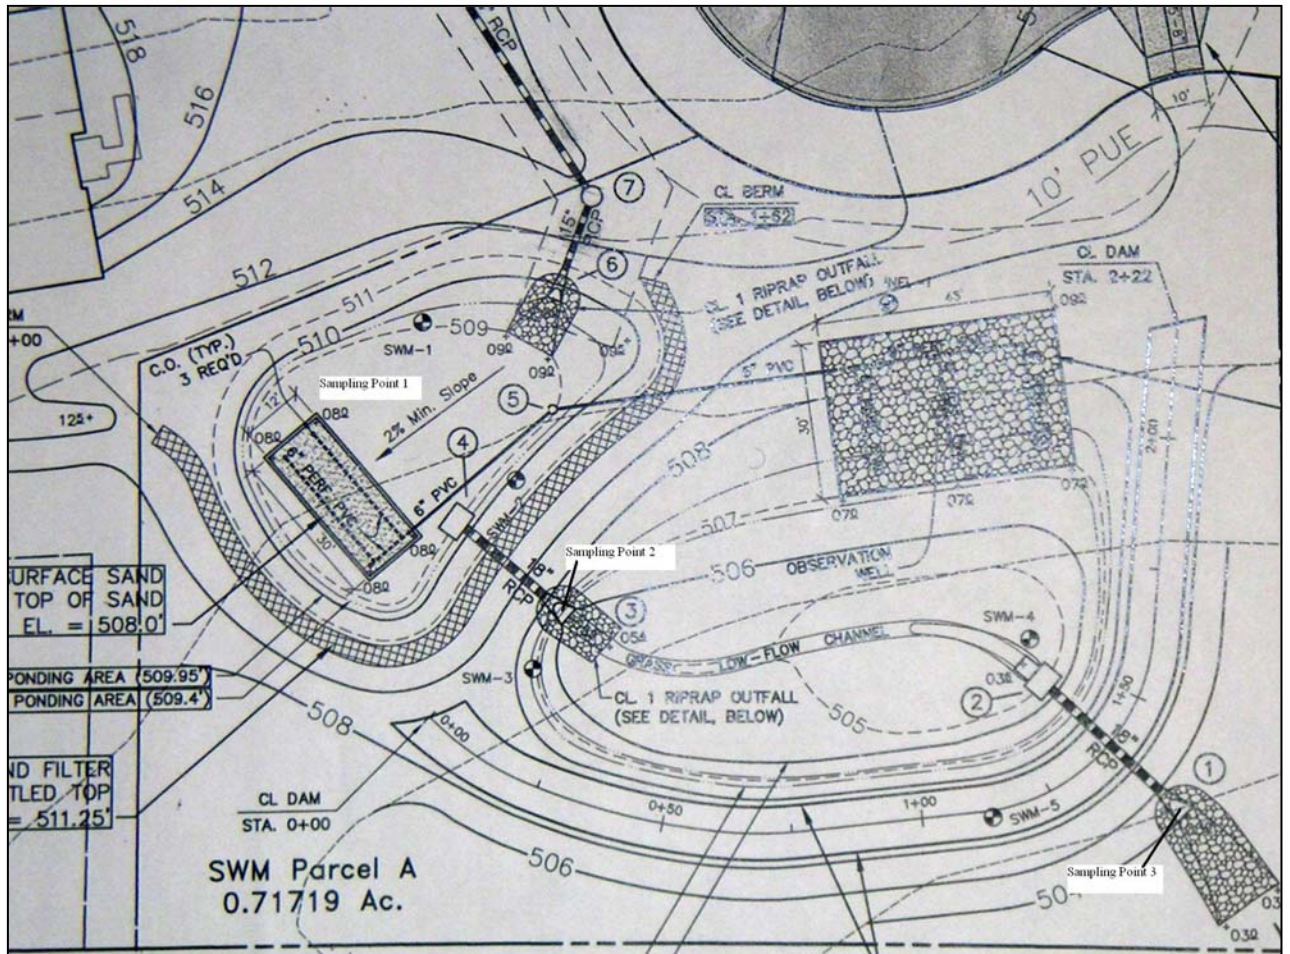
**Figure TA-3.12. Plan view of Snider's Estates SWM with marked sampling locations.** The plan illustrates during construction sampling points (3) and the discussed post-construction flow monitoring station (Sampling Point 2).

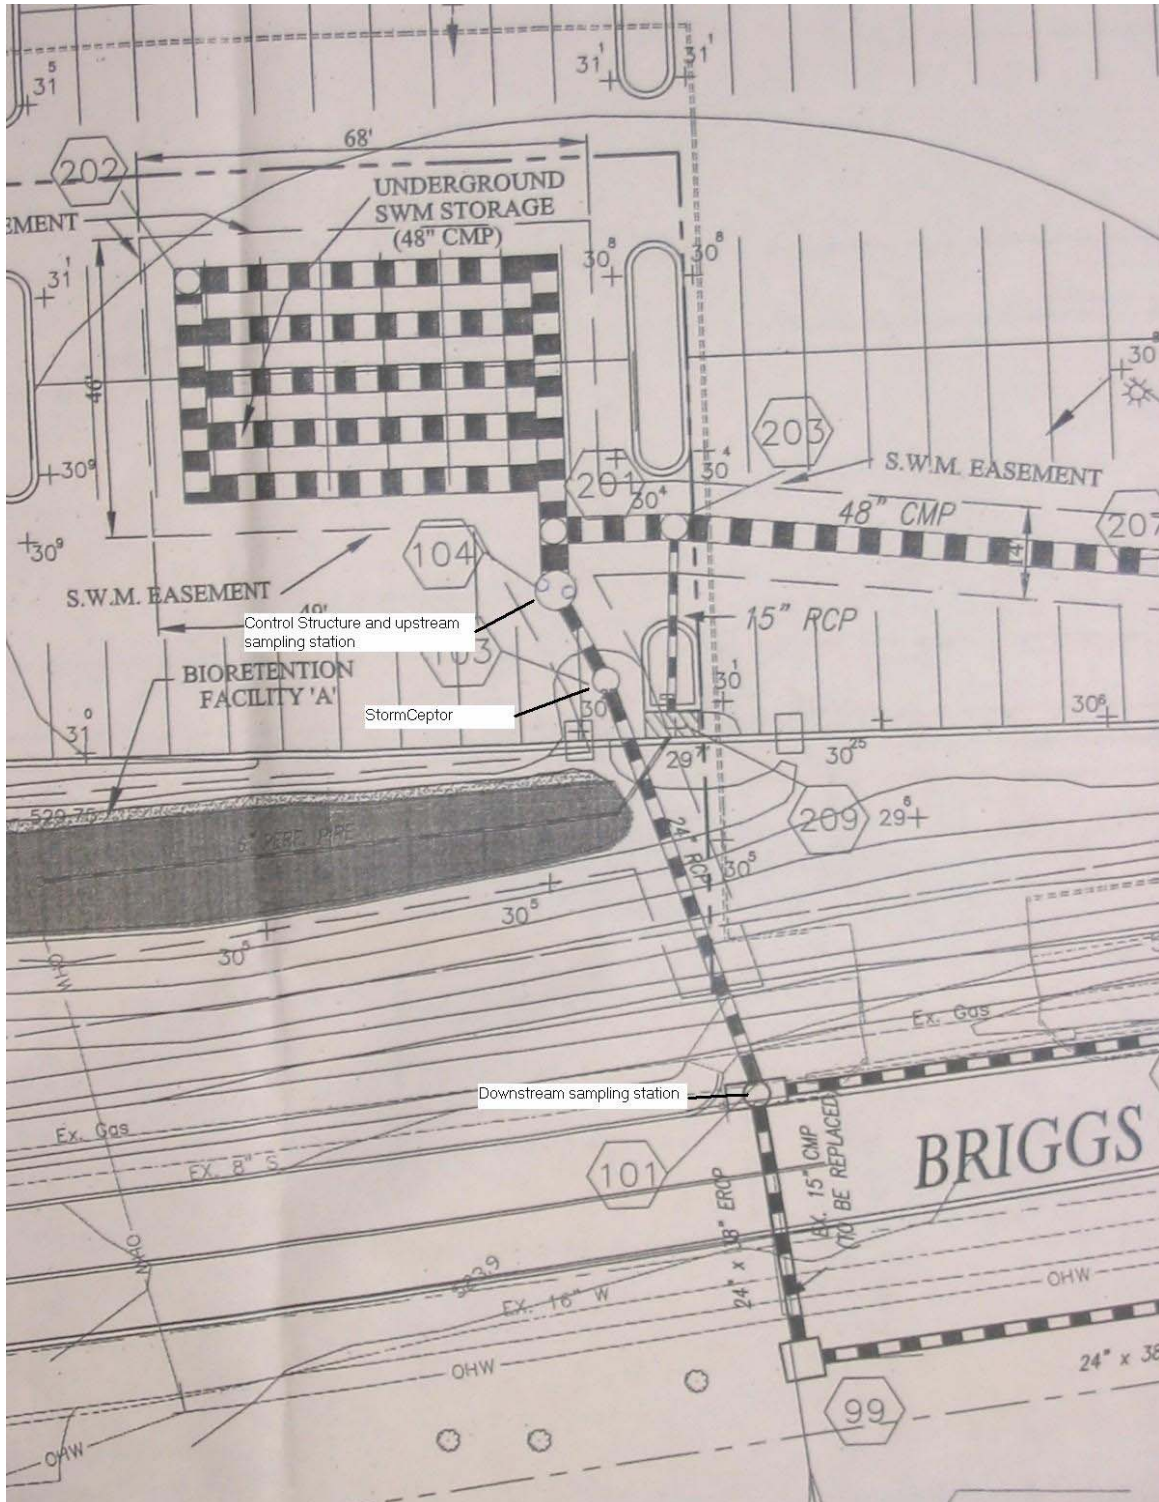
**Figure TA-3.13. Diagram of Cloverly Safeway SWM BMPs with marked sampling locations (2).**

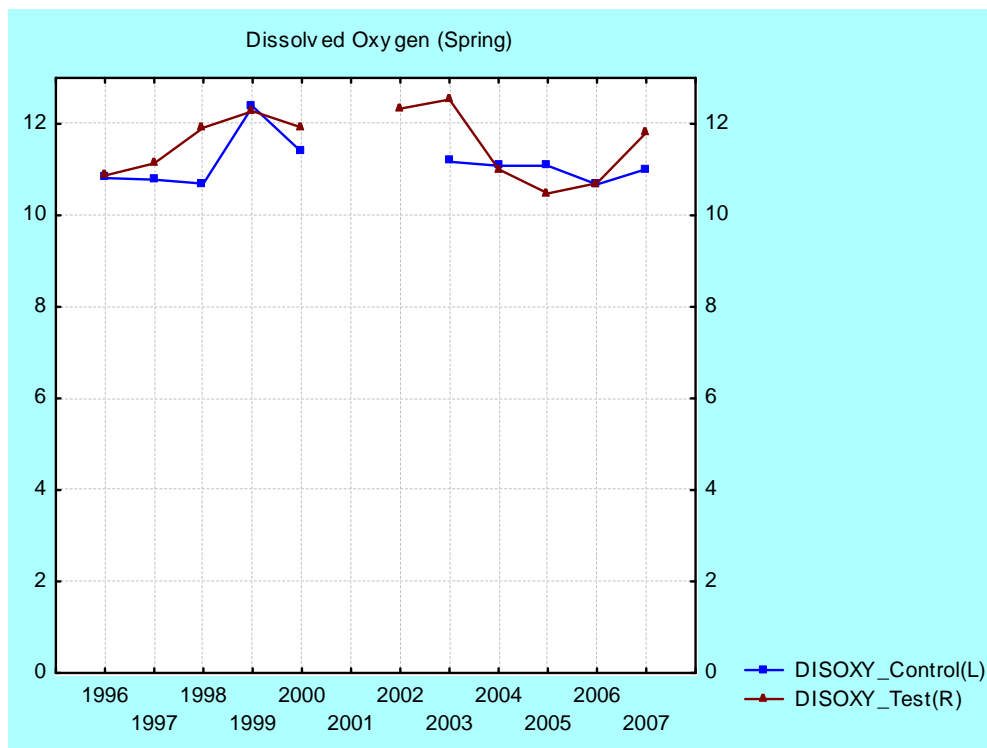
**Figure TA-4.8. Spring Dissolved Oxygen Comparisons between the Clarksburg Master Plan SPA Test and Control Stations.**

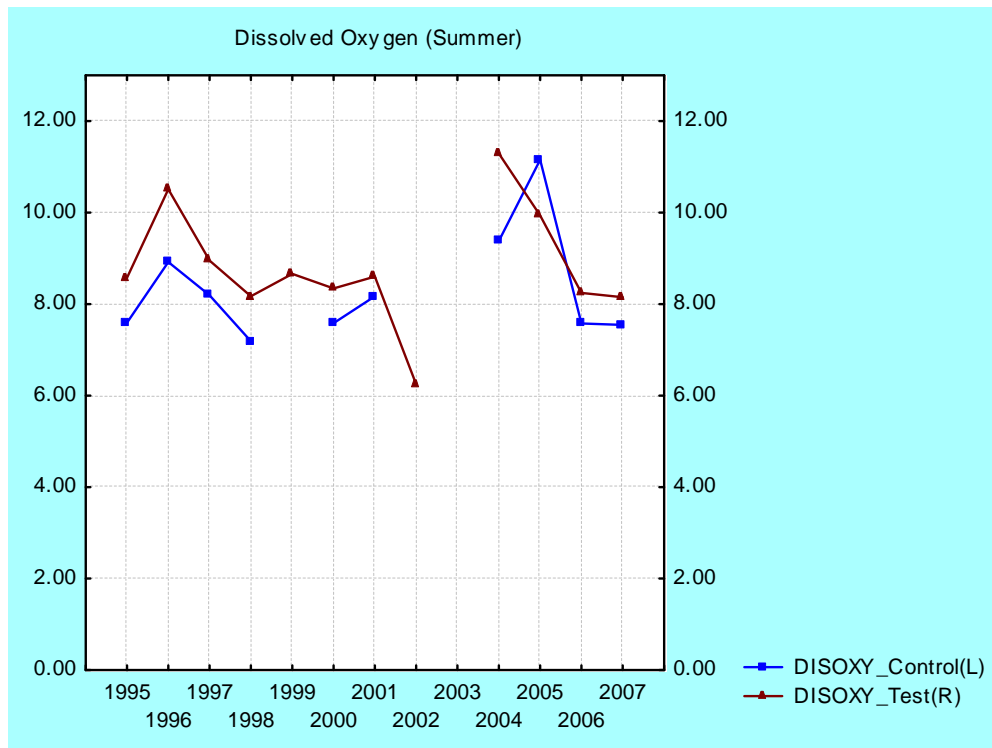
**Figure TA-4.9. Summer Dissolved Oxygen Comparisons between the Clarksburg Master Plan SPA Test and Control Stations.**

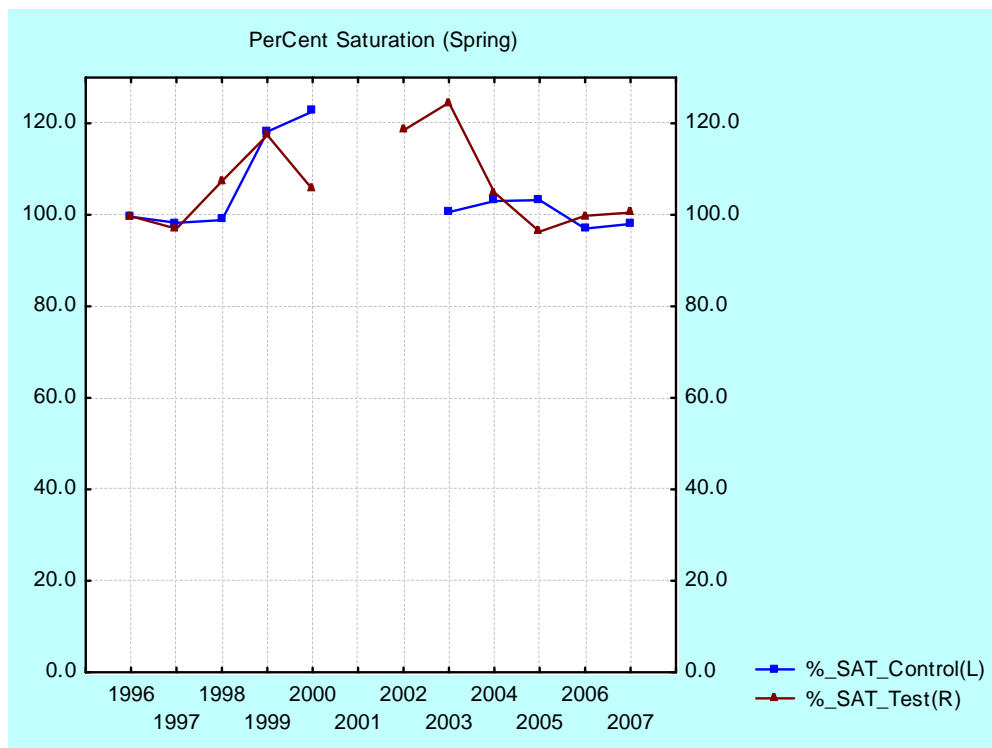
**Figure TA-4.10. Spring Dissolved Oxygen Per Cent Saturation Comparisons between the Clarksburg Master Plan SPA Test and Control Stations.**

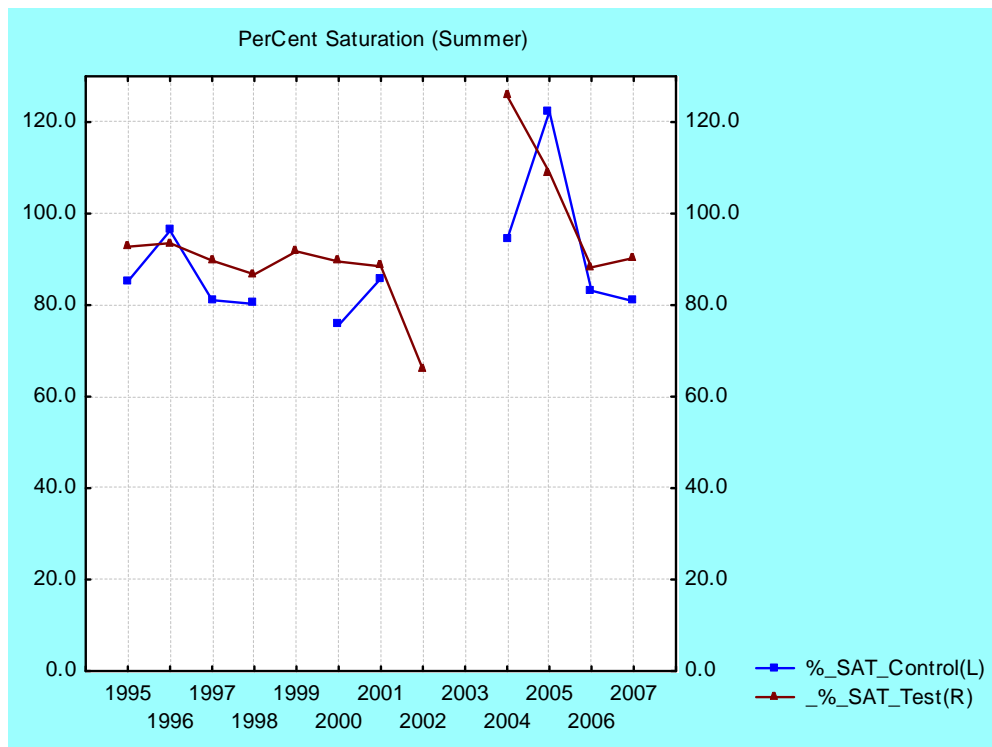
**Figure TA-4.11. Summer Dissolved Oxygen Per Cent Saturation Comparisons between the Clarksburg Master Plan SPA Test and Control Stations.**
